# Manhole Inspection Summary

Manhole # S01AA2008MH

Insp Date: **8/10/06 9:15 AM**

**Location** Address: **3200 W STRATHMORE AVE**

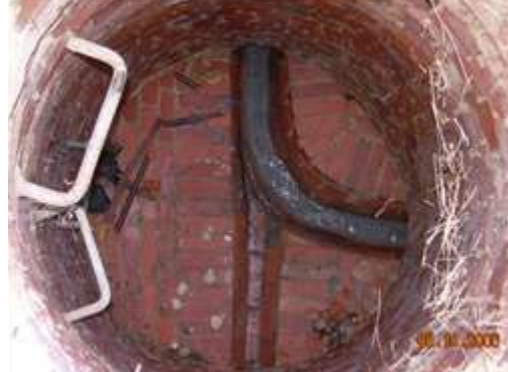
Top View

Adjustment, Corbel and Barrel infiltration.  
Bench debris.

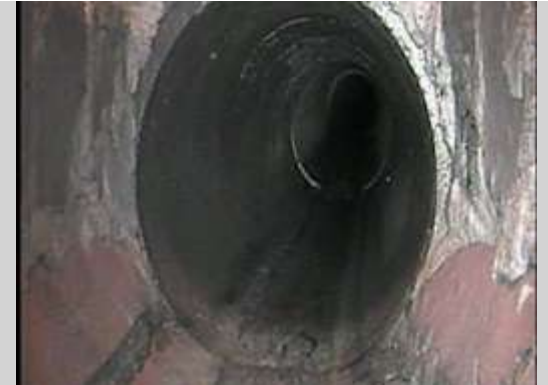
### 8 in. Circular Gravity Sewer Pipe Out @ 12 O'Clock

Invert Depth: **7.30** (ft.) Flow Characteristics: **Slow**

Infiltration: **Evidence** Pipe Seal Cond: **Unknown**

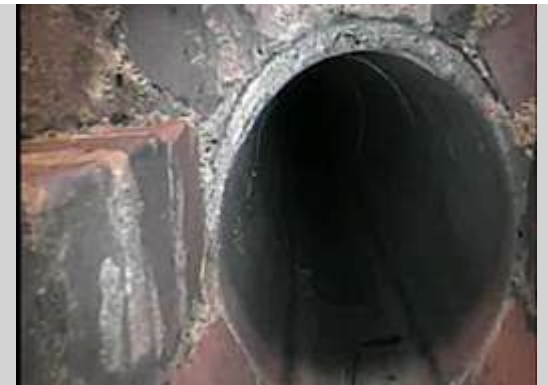
### 8 in. Circular Gravity Sewer Pipe In @ 3 O'Clock

Invert Depth: **7.23** (ft.) Flow Characteristics: **Slow**

Infiltration: **Evidence** Pipe Seal Cond: **Unknown**

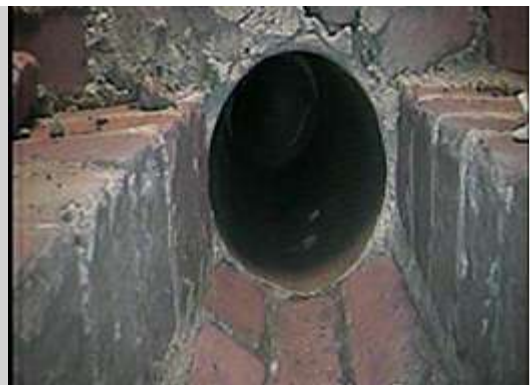
Pipe In @ 6 O'Clock

Invert Depth: **7.05** (ft.) Flow Characteristics: **Slow**

Pipe Seal Cond: **Cracked**
